Cheakamus Community Forest
Forest Service Road and Bridge Summary Report

January 11, 2010

Cheakamus Community Forest FSR Inspection

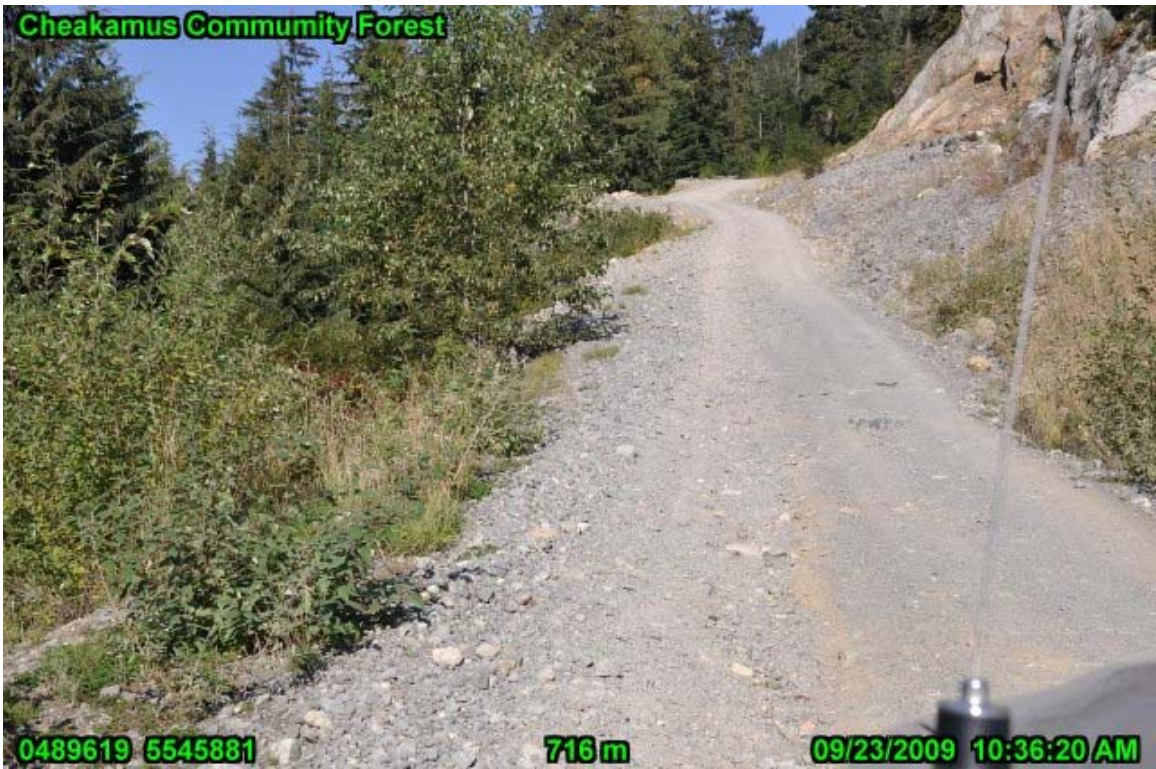
3.16 Km – Brandywine FSR

Km Location	Comments
0.00 Km	Junction w/ Callaghan WOP access road
1.19 Km	Junction w/ original Brandywine FSR (8079.01)
0.00 Km	Reset at above noted FSR junction
1.70 Km	Penstock crossing
3.16 Km	Steep grade w/ surface erosion. Minimal cover over penstock
3.45 Km	Bridge 3097 – Log stringer w/ penstock adjacent
3.60 Km	Narrow section w/ fill slope erosion & raveling. Penstock upslope
4.44 Km	Junction to upper Brandywine Meadows access
5.89 Km	Start of steep rough grade
6.63 Km	End FSR at Brandywine Meadows trailhead

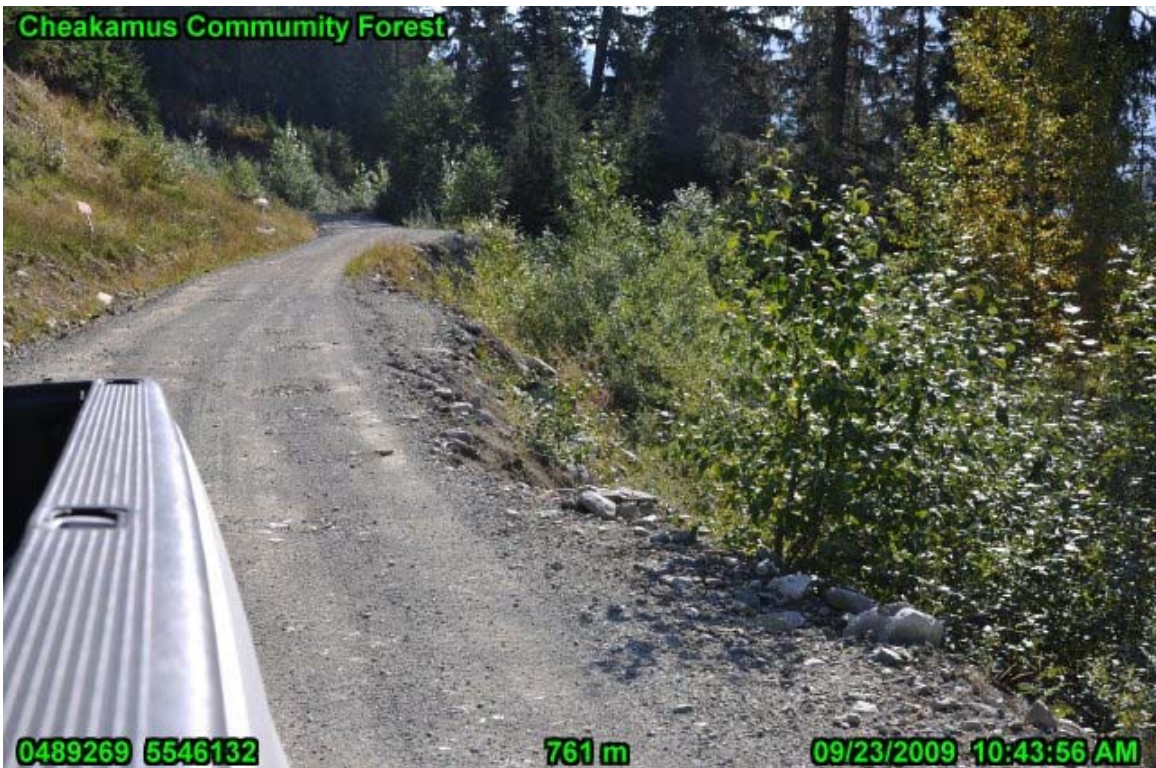
3.60 Km – Brandywine FSR

There were several short sections of concern, for example the fill slope at 3.60 km on the Brandywine FSR and the armoured section of the Cheakamus West FSR at 4.03 km, and these are noted in Appendix A, although currently they are in good repair.

This FSR section is generally in very good condition, and given topographical constraints, is appropriate for current and future use. The only area of significant concern is the fill slope at approximately 3.60 Km. In this area the running surface is narrow, and the fill slope exhibits some signs of instability, including raveling and surface erosion. The location of the penstock immediately upslope precludes the possibility of moving the road further into the bank, and it is likely that penstock location actually "crowded" the road to the outside.

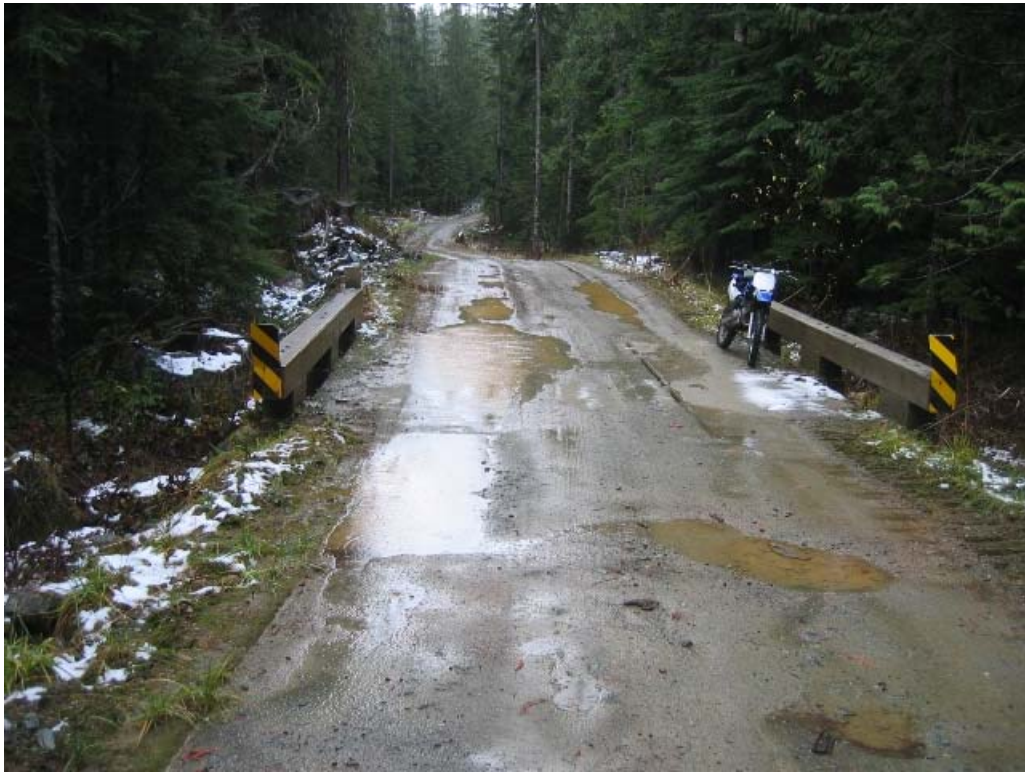
2.27 Km – Brew Creek FSR

Km Location	Comments
	<i>10490.01</i>
0.00 Km	Junction w/ Hwy 99
0.50 Km	Junction w/ paved campground access
2.01 Km	Bridge 3239 – log stringer approx. 8 m span
2.27 Km	Bridge 3240 – concrete approx. 4 m span
2.36 Km	Bridge 3241 – concrete approx. 4 m span
3.17 Km	Bridge 3242 – log stringer approx. 6 m span
3.64 Km	2 Wood box culverts
3.90 Km	Junction w/ FSR 10490.02
5.43 Km	Bridge 3243 – railcar. End FSR
	<i>10490.02</i>
0.00 Km	Junction w/ 10490.01
1.11 Km	Start existing perm. Deactivation. End FSR

There are five bridges and two large wood box culverts (WBCs) on FSR 10490.01. These WBCs and the two log stringer bridges would require inspection and detailed load calculation prior to any industrial use, with replacement likely in the longer term.

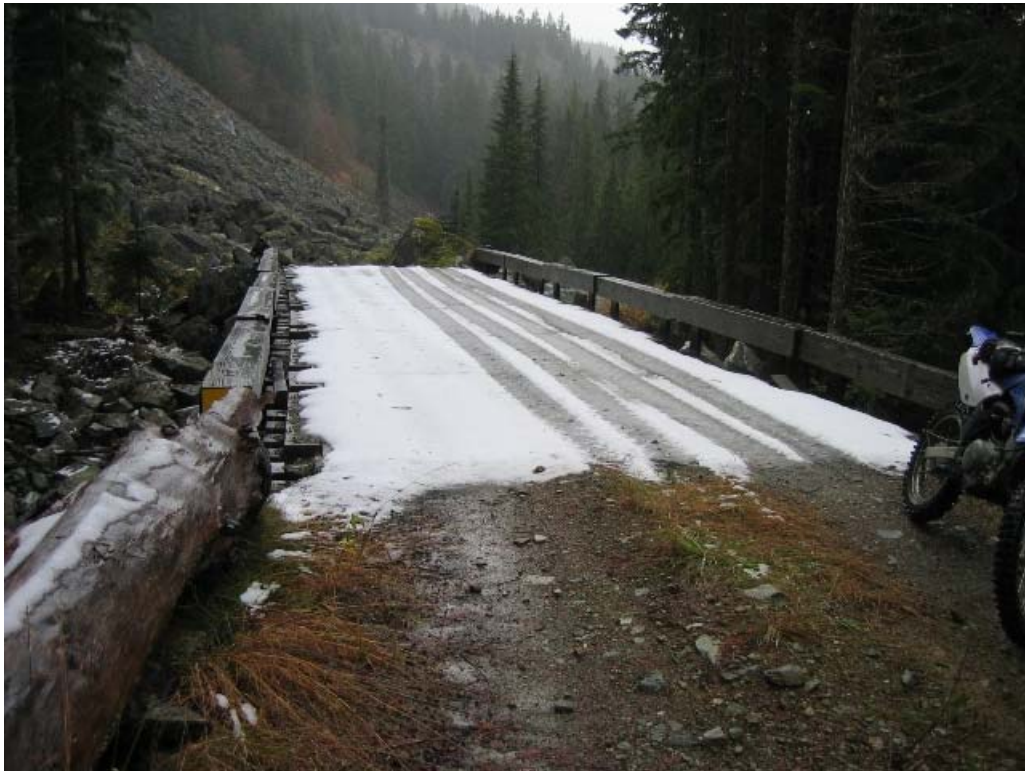
5.43 Km – Brew Creek FSR

These FSRs are in good maintained condition, with minor rough sections. The upper section of FSR 10490.01, beyond the junction with 10490.02, has some water bars but is easily passable with a full size 4WD vehicle. 10490.02 was recently reactivated to access blocks harvested earlier this year. The majority of public use appears to be firewood gathering, likely with fall hunting use as well.

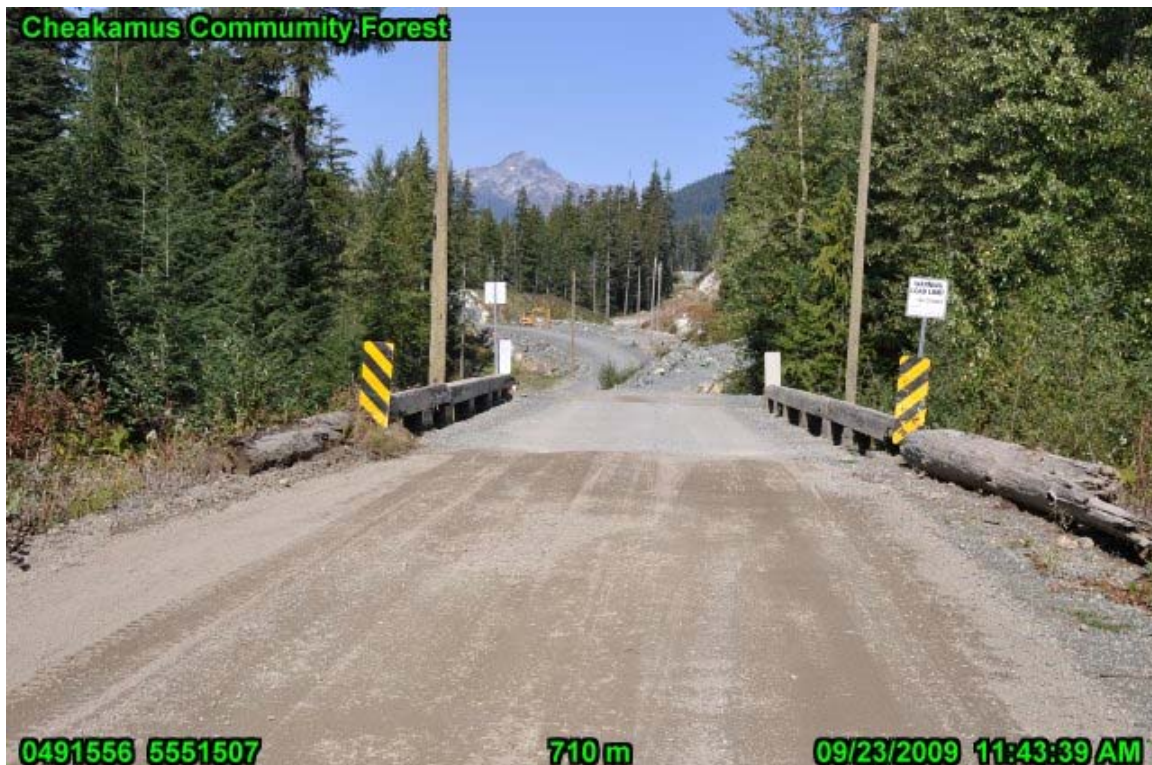
6.13 Km – Callaghan FSR

Km Location	Comments
0.00 Km	Junction w/ Hwy 99
4.86 Km	Bridge 3030 – Steel w/ concrete deck
6.13 Km	Bridge 3031 – Steel w/ concrete deck
6.46 Km	Junction w/ WOP access road

There are two bridges on this section of FSR, each with steel girders and concrete decks.

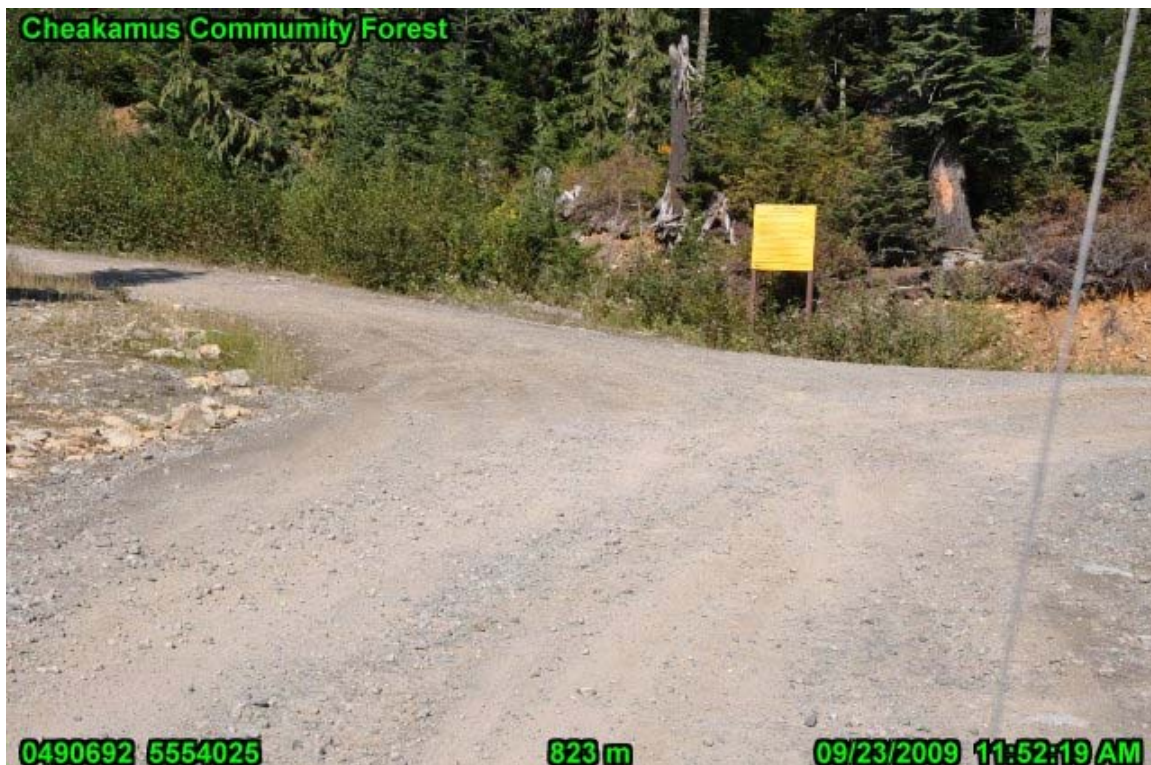
0.34 Km – Upper Callaghan FSR

Km Location	Comments
0.00 Km	Junction w/ WOP access road
0.00 Km	Bridge 3032 – Steel w/ concrete deck
0.34 Km	Junction w/ historic Madeley FSR
6.58 Km	Callaghan Provincial Park boundary

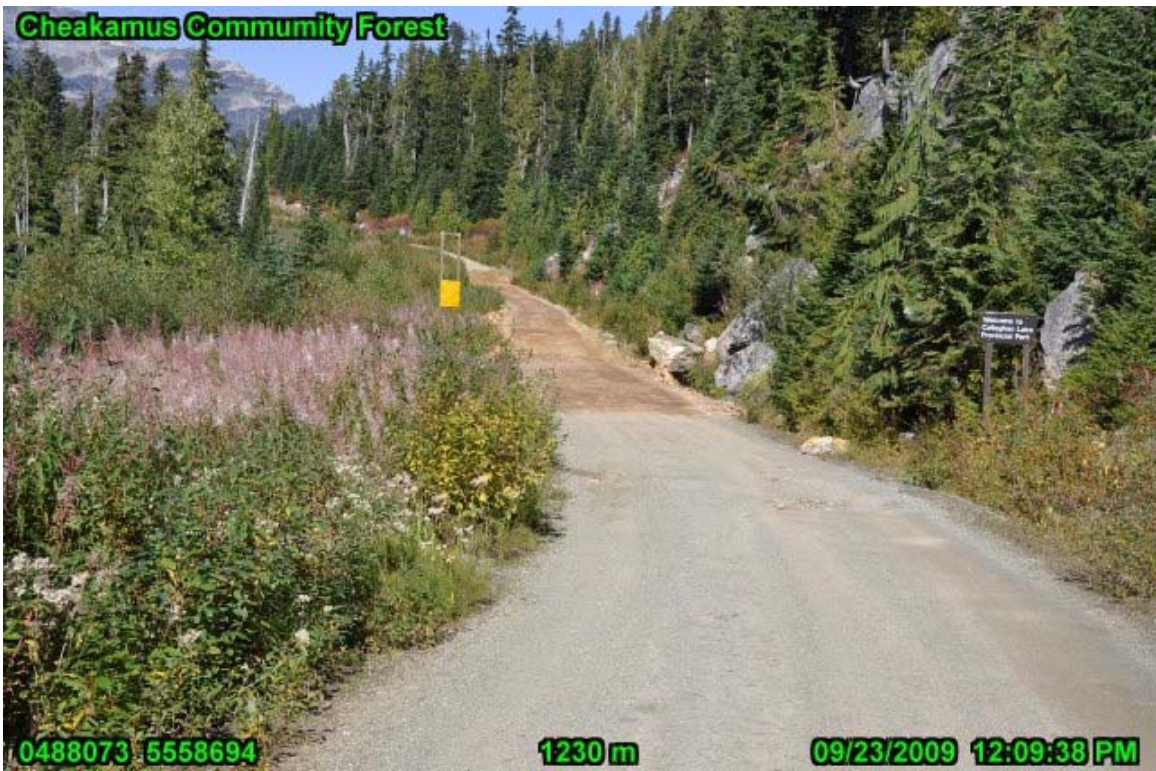
6.58 Km – Upper Callaghan FSR

This FSR provides access to Callaghan Lake Provincial Park and is heavily used by recreational users, primarily during summer and fall. The road is in good condition, with some rough areas as a result of infrequent maintenance. Grades would permit passage with cars; however there are many wide and smooth cross ditches to control surface erosion and runoff which likely block access to most cars. High clearance 2WD or 4WD is currently required.

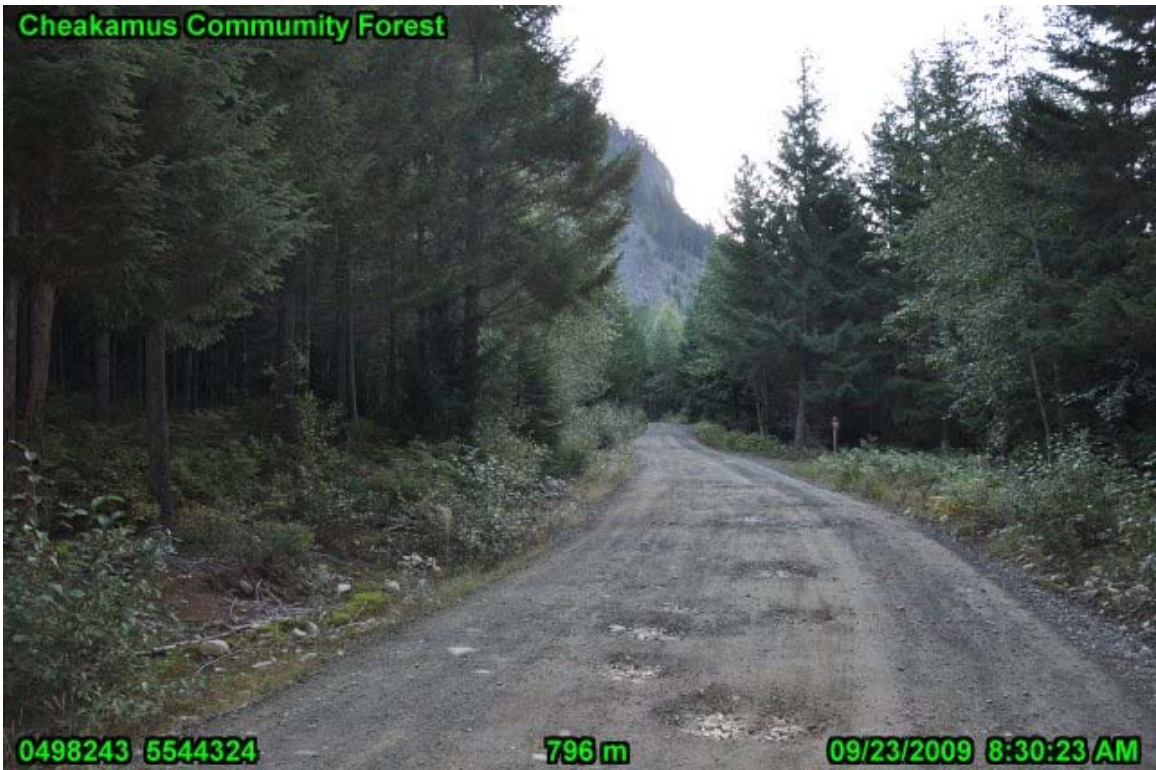
Cheakamus River FSR

This FSR is generally in good condition, commonly travelled by cars, with well controlled drainage and a stable road prism. However the running surface is very rough and is heavily pot holed over much of its length. This is a result of lack of surfacing material, infrequent grading, and heavy traffic. At approximately 6.11 Km there is a till bank at the top of a steep gully that has failed at some point in the past. It appears that the road has been repaired at this location, with the cut bank sloped back, guide logs placed on the outside edge, and a large ditch installed to ensure drainage of the road prism, and currently there appears to be no concern in this area.

Based on the access to the Cheakamus Lake trailhead and the various other trails along the road, this FSR would benefit from a full surface upgrade. This would consist of cleaning or improving existing ditches, lifting the running surface in the few low sections, and the application of suitable crush material over the entire road. This would provide a much more easily maintained running surface which, when combined with much more frequent grading, would give easier access, particularly for cars, than in its current condition.

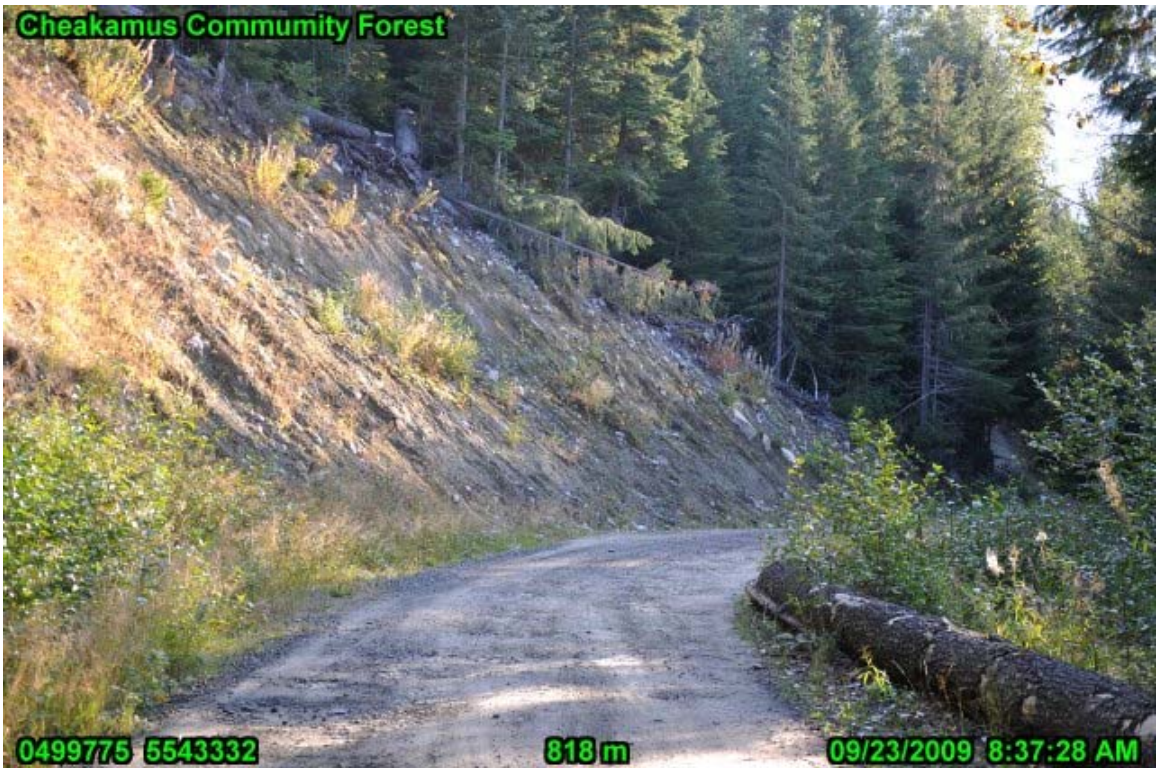
6.11 Km – Cheakamus River FSR

Km Location	Comments
0.00 Km	Junction w/ paved access road
6.11 Km	Till bank w/ gully downslope
7.13 Km	Cheakamus Lake trailhead

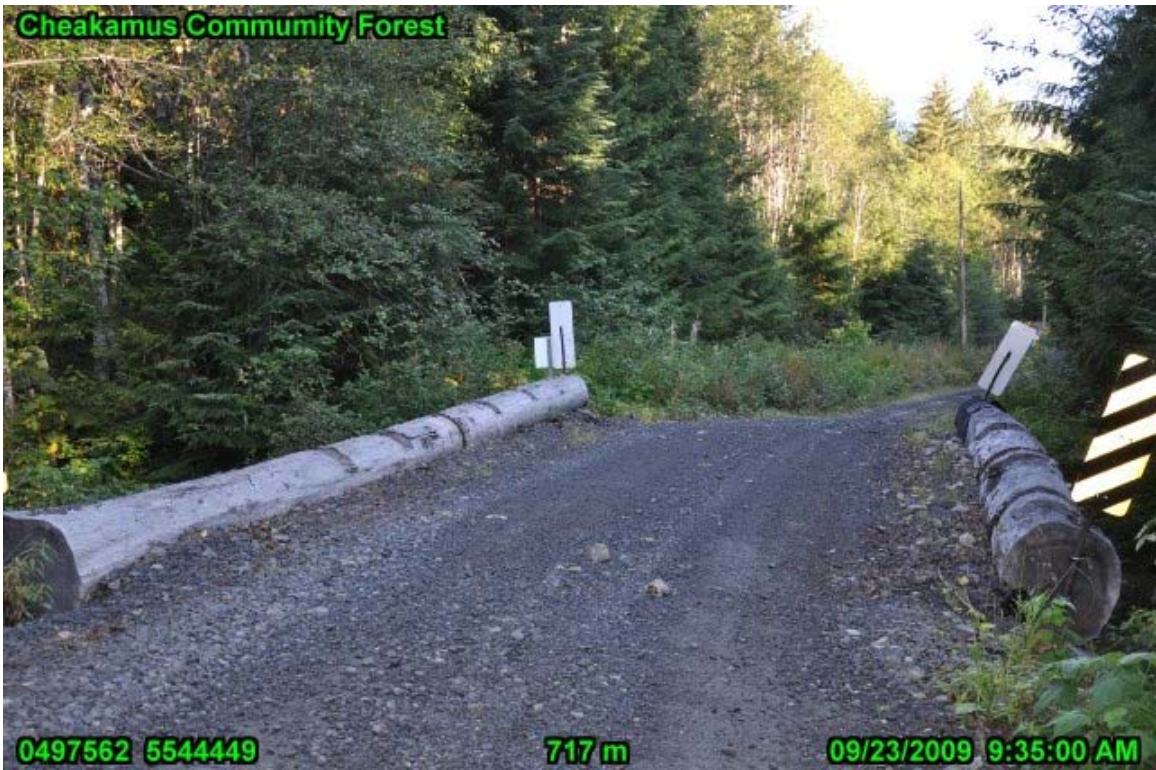
3.82 Km – Cheakamus River South FSR

Km Location	Comments
0.00 Km	Junction w/ FSR 3077.01
0.10 Km	Bridge over Cheakamus River
1.32 Km	End 2WD access. Rough hill w/ multiple water bars
2.41 Km	Loggers Lake trailhead
3.30 Km	Wood culvert 3199
3.66 Km	Bridge 3173 – Railcar bulkheads
3.82 Km	Bridge 3174 – Log stringer w/ 5 T posted load
3.89 Km	Bridge 3175 – Log stringer w/ 5 T posted load
4.03 Km	Armored bank on Cheakamus River
4.91 Km	Gate at 3077.07 FSR junction

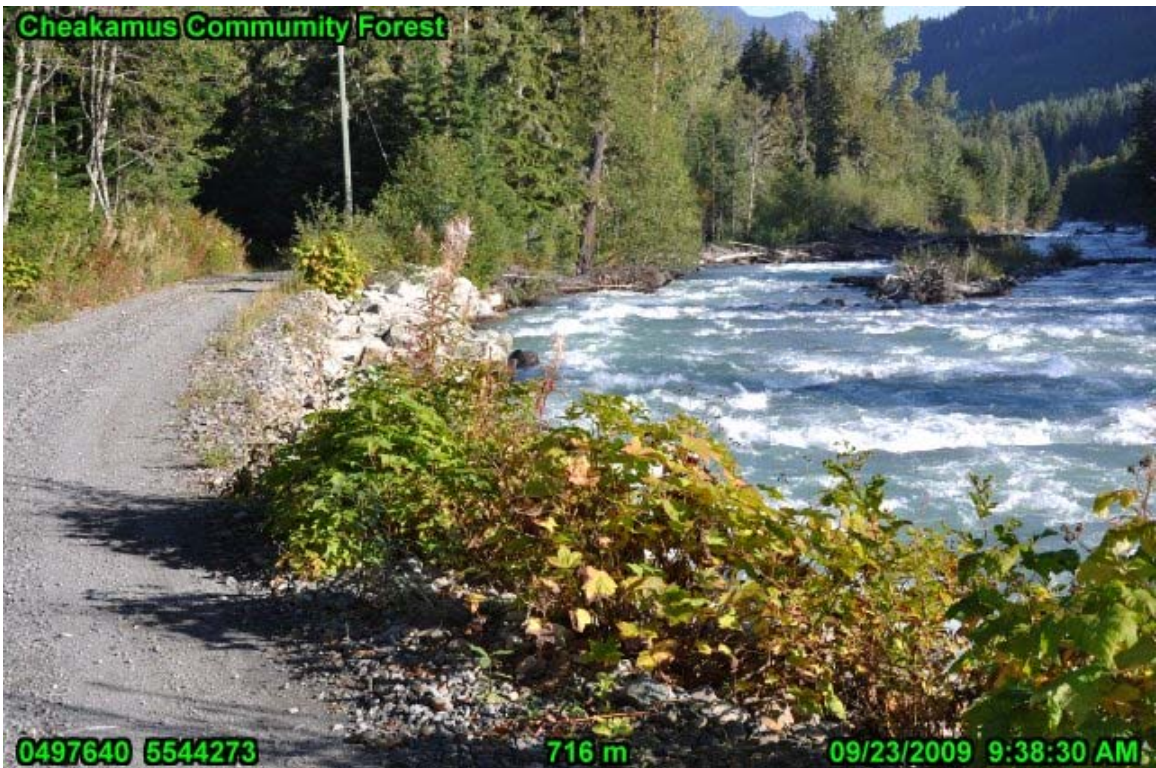
4.03 Km – Cheakamus River South FSR

At 4.03 Km the FSR is immediately adjacent to the Cheakamus River and the bank is armored with large angular rock. It is expected that after some significant high water events repairs or maintenance to this section might be required. At the 4.91 Km mark there is a gate blocking access to the remainder of the FSR that accesses the Black Tusk microwave tower site.

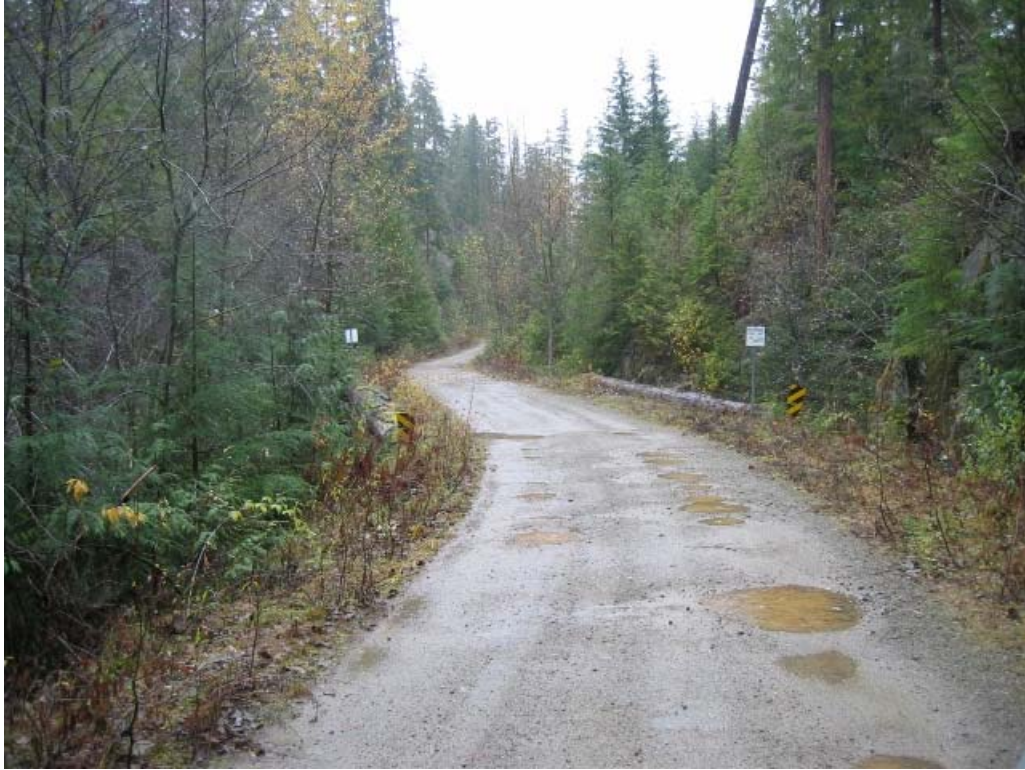
5.22 Km – Daisy Lake FSR

Km Location	Comments
	<i>9281.01</i>
0.00 Km	Junction w/ Hwy 99
0.88 Km	Bridge 3127 – Cheakamus River
3.25 Km	Whistler Bungee parking and facility
4.35 Km	Low section – very rough/pot holed
5.22 Km	Bridge 3128 – log stringer w/ 10 T posted load
6.18 Km	Junction w/ 9281.02
12.39 Km	Bridge 3182 – log stringer w/ 30 T posted load
13.18 Km	Southern junction – end FSR. Start deactivated sections
	<i>9281.02</i>
0.00 Km	Junction w/ 9281.01
1.07 Km	Bridge 3181 – log stringer w/ 68 T posted load
1.55 Km	End at junction w/ spurs blocked – end FSR

To approximately the 3.25 km point, where the Whistler Bungee facility is located, FSR 9281.01 is in well maintained condition and would be passable in most 2WD vehicles. Beyond this point the road is rougher, with a particularly poor section at 4.35 km, but is structurally sound, with no unstable or sloughing sections noted. Beyond the junction with FSR 9281.02 the grades get steeper, however still easily passable with a full sized 4WD vehicle. There appears to be relatively little public use of the Daisy Lake FSRs past the 3.25 km point, although typical rustic campsites were noted.
